PILEDRIVER PUMP

Model 2103,2123,2143, 2163,2183,83603

83603 PUMP TUBE ASSEMBLY SERIES "D"

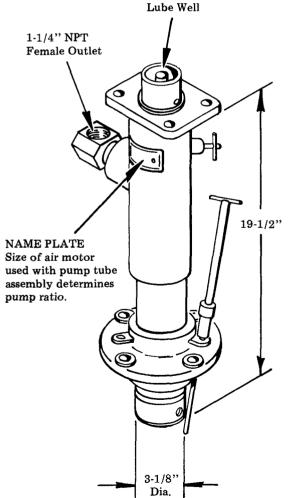
GLAND PACKING LUBE WELL

Many materials such as ink, undercoating, buffing compounds etc., display a tendency to build up and dry out on the pump rod. These hard dried out materials cause the gland packings to wear out rapidly, resulting in leakage. If the material can be prevented from drying and hardening on the pump rod the gland packings can be expected to have a normal service life.

The lube well should be filled with a fluid compatible with the material that is to be pumped. This fluid will prevent the material from drying out on the pump rod and becoming abrasive.

The lube well is accessible for inspection and filling by removing the Power Master name plate from the side of the air motor.

Do not fill lube well to full capacity as the reciprocating movement of the air motor piston rod may draw the fluid into the air motor.

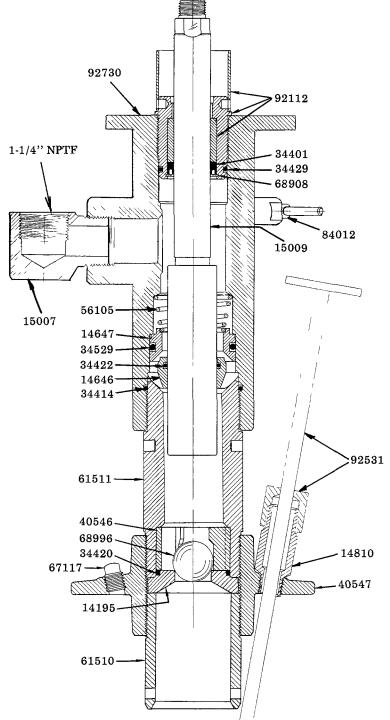
SERVICE OF LOWER PUMP TUBE

Loss of volume and pressure or continuous operation of pump when not in normal use indicates:

- 1. Material supply in drum may not be adequate.
- 2. Air supply may not be adequate. Check setting of air regulator of air supply line.
- 3. Pump may operate on the "down stroke" only, due to material by-passing around the 14647 check. Inspect Check, 14646 check bushing, 34529 "O" ring, and 34422 "O" ring for wear. Replace parts if necessary.
- Pump is operating but not dispensing material. 68996 check in foot valve is not seating. Inspect check and seat for foreign particles or wear. Replace parts if necessary.
- Material by-passing "U" cup packing in gland assembly. Inspect "U" cup packing and replace if necessary.
- Piston rod may be scored, pitted or worn. Replace Piston rod.
